## Flocculant - Floor adhesion test report

- Evaluate the performance of the versatile absorbent Polycaptor® and a mineral absorbent like sepiolite on an accidental flocculant spill.
- Measure floor adhesion of the area after cleaning by an approved independent company

Floor adhesion is measured by a Skid Resistance Tester (SRT) according to European standards. The tests are carried out on a potential spill site in the factory.

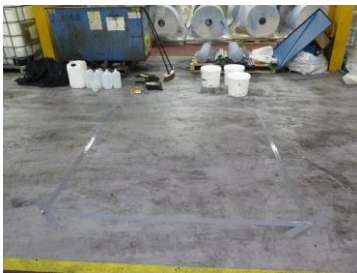
Spill area

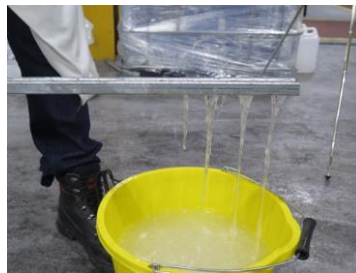
Flocculant before spill on the floor

The **flocculant spill** causes a **30% loss of floor adhesion**.

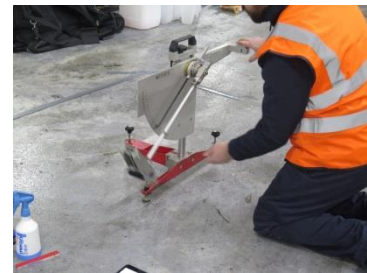
Skid resistance tester

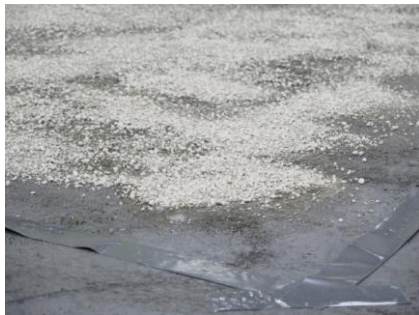
### MINERAL ABSORBENT

Absorption and cleaning of the floor

The **mineral absorbent** absorbs the flocculant but **does not permit to restore floor adhesion**. A residual layer of flocculant remains: -32% of adhesion compared to the original floor.
